FIELD REPORT

DATE: Monday, May 21, 2012

PROJECT: Independence Park Main Library

REPORTED BY: Lisa C. Hargrave, AIA - The Library Design Collaborative

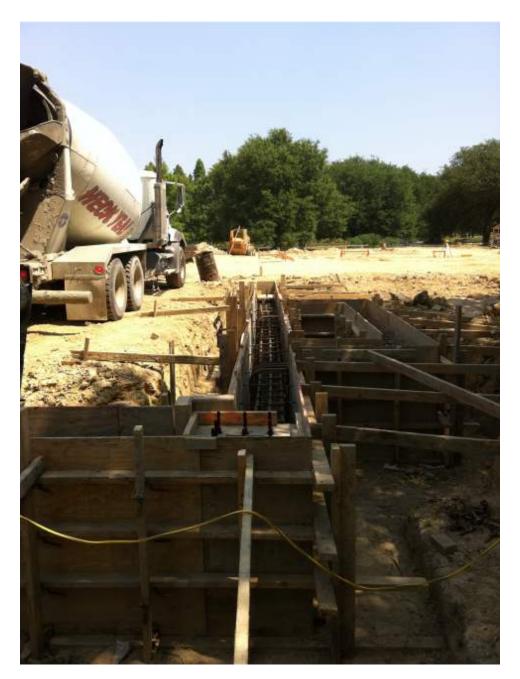
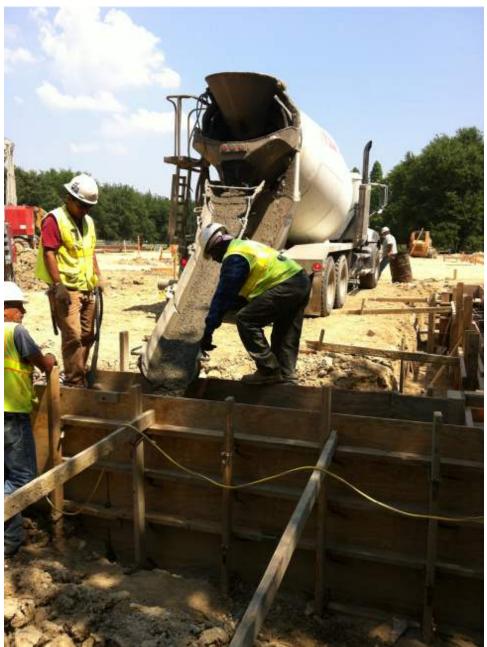
- 1. The architect observed the form and rebar for the gradebeam along column line A19 from 03 to 52. In some locations the rebar cage was closer to the form than the 3" minimum indicated on the drawings. The general contractor was notified and this was modified.
- 2. The architect observed part of the grade beam pour (Col. Line A19/03-52). A slump test was taken from the front of the first truck. The pour progressed concurrent with test, which came out at 6" of slump. The tolerable range was stated to be between 4 and 6".
- 3. Robbie Posey was laying out the grid for the "connector" (Vestibule 107, Corridor 106) and the Meeting room. The architect pointed out that C01 should extend to the west to Columnline B17 and that C01, B17, and 56 should meet at the same point as shown. If not, the architect should be notified.
- 4. Steel was being erected west of columnline 11.
