FIELD REPORT

DATE: Wednesday, May 9, 2012
PROJECT: Independence Park Main Library
WEATHER CONDITIONS: Overcast - 79°
SITE CONDITIONS: Muddy
NUMBER OF WORKERS ON SITE: Approx. 20-25
REPORTED BY: Lisa C. Hargrave, AIA - The Library Design Collaborative
IN ATTENDANCE: Lisa C. Hargrave, Bryan Hume, Josh Peak, Chris Washer, and George Griffon

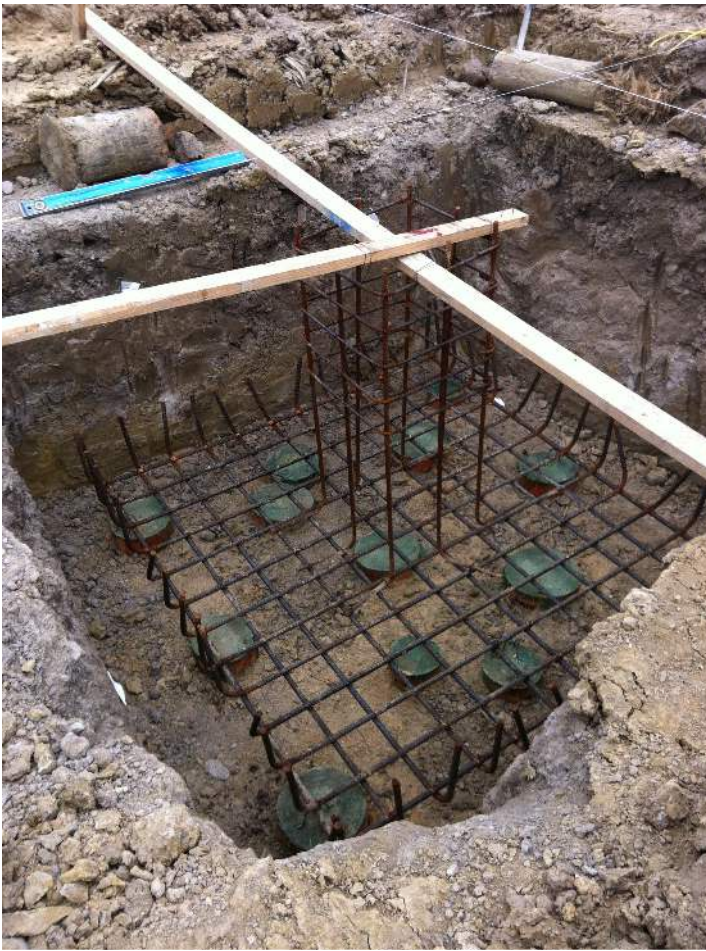
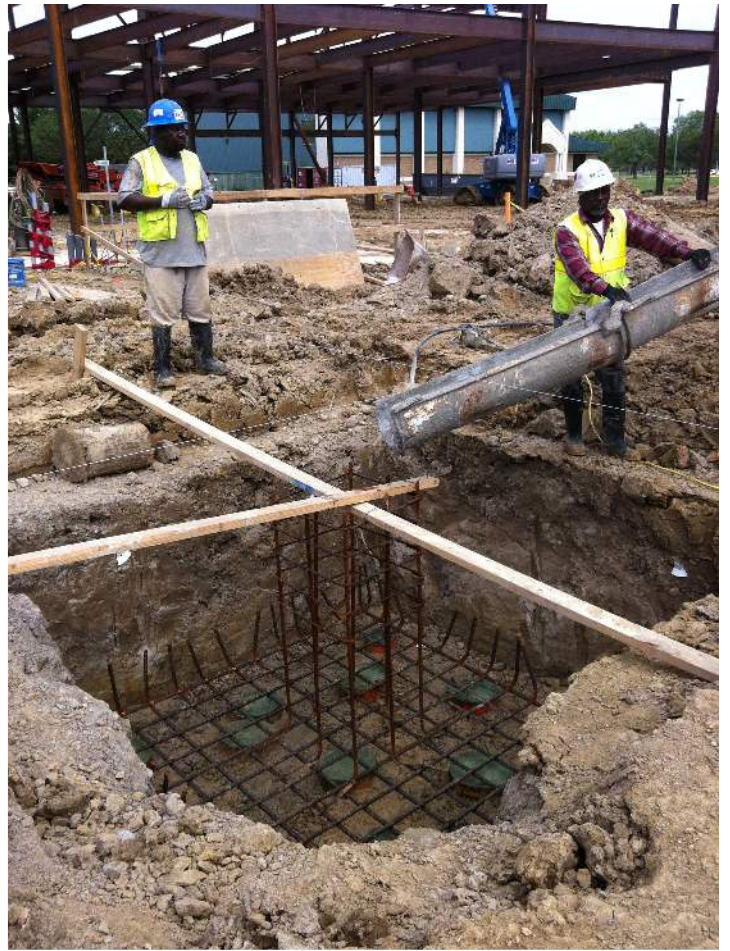
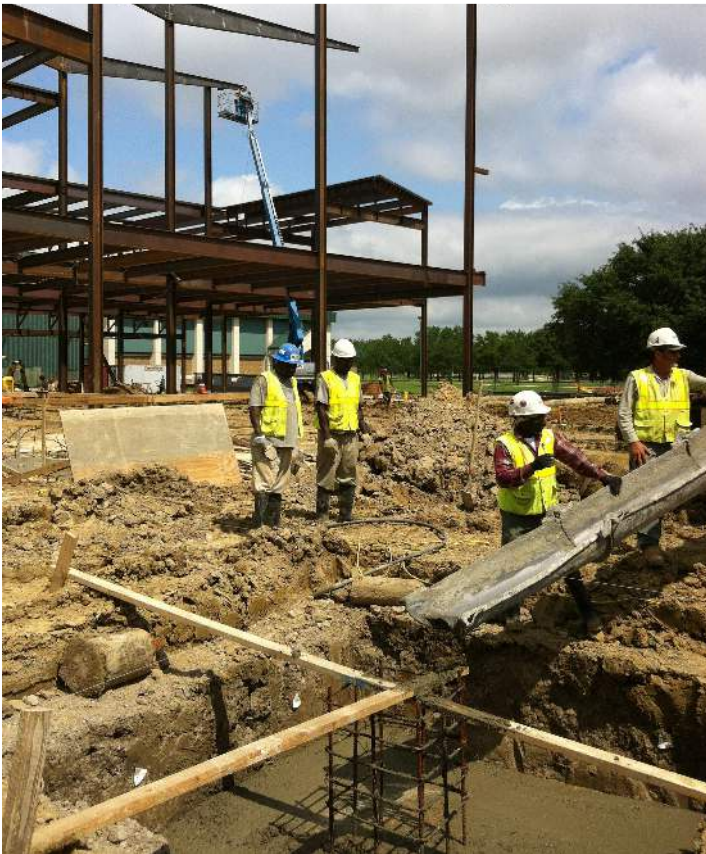
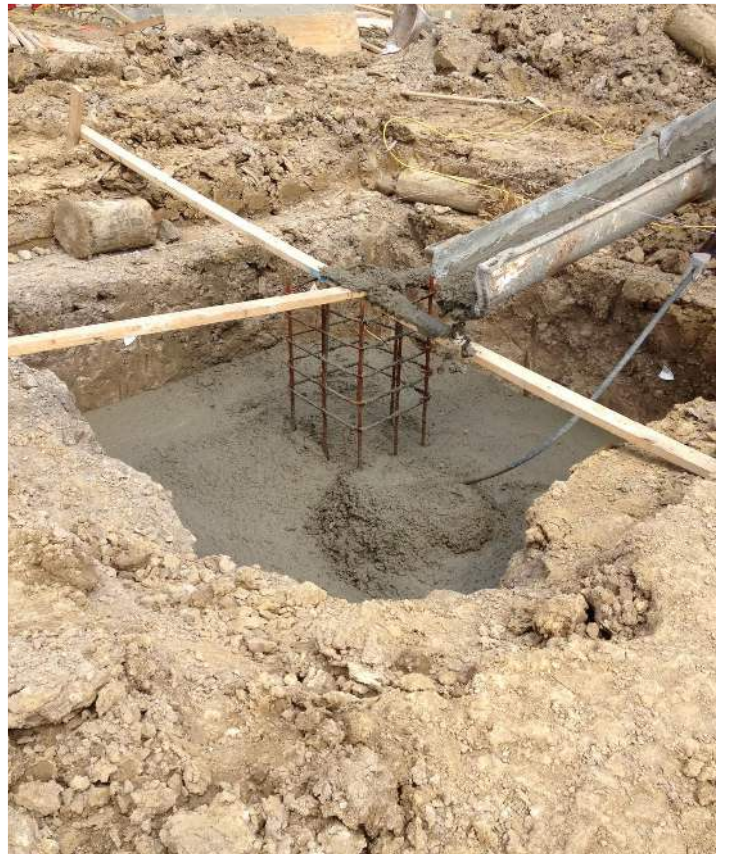
06 and A11
April 30, 2012, 11: 10 am

1. The architect reviewed the holes and rebar placement for the pile caps at columnline 06 and A11, A13, A14, A15 as well as the concrete pour at the pile cap at 06 & A11.
2. The first truck of concrete poured at pile cap 06&A11 was somewhat inconsistent ranging from a more liquid consistency to a clumpy one. The work of the vibrator seemed to mix it fairly well once it was in the hole. The concrete from the second truck was more consistent.
3. The architect reviewed the status of the steel erection. Two of the "butterfly" beam sections were erected at columnlines B05 and B06 in addition to most of the steel from columnline A01 to B05.
4. The fence near easternmost tree behind the BREC performance art building was down and the silt fence at the north west corner of the site was also down. (see attached images) When I pointed these out, George indicated that these would be corrected.
