## FIELD REPORT

**DATE:** Thursday June 28th, 2012

**PROJECT:** Independence Park Main Library

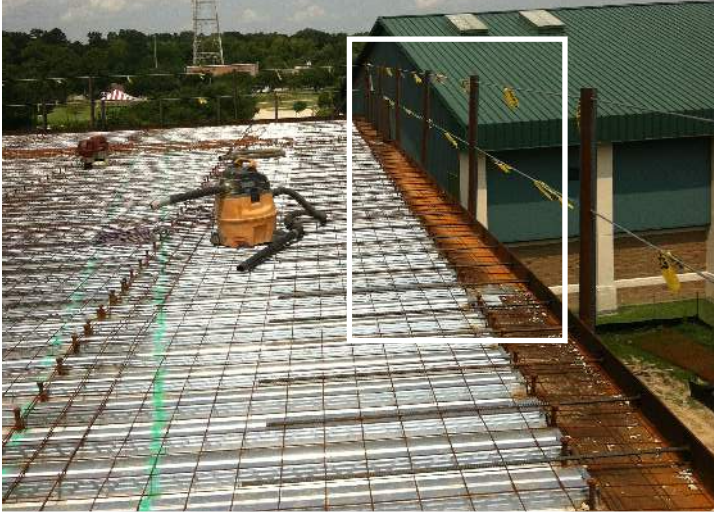
Refer to note 2a

- a. At the north roof area along columnline 57 the architect noted several channel stub-ups that needed to be removed. In this location the parapet wall is beyond column 57 allowing the studs to be cantilevered from below negating the need to steel in this area. (RE: 1AE352)

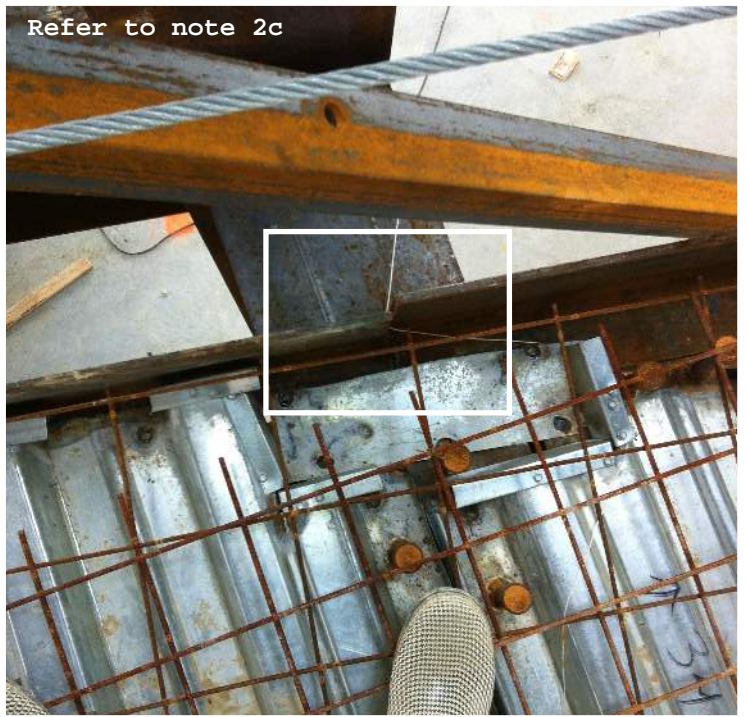
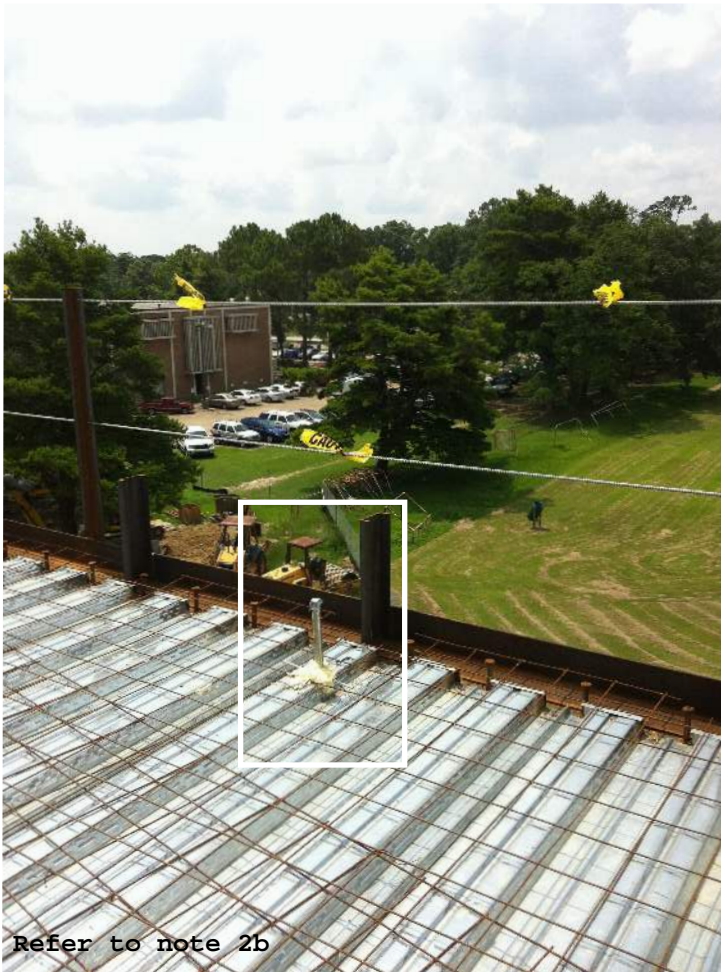
Refer to note 2c

- c. At the slab edge near columnline 52 at columnline A05, the architect noted an offset in the edge angle alignment. The contractor indicated that this mal-alignment would be remedied in the stud wall furring in this area to create a smooth and flush wall.

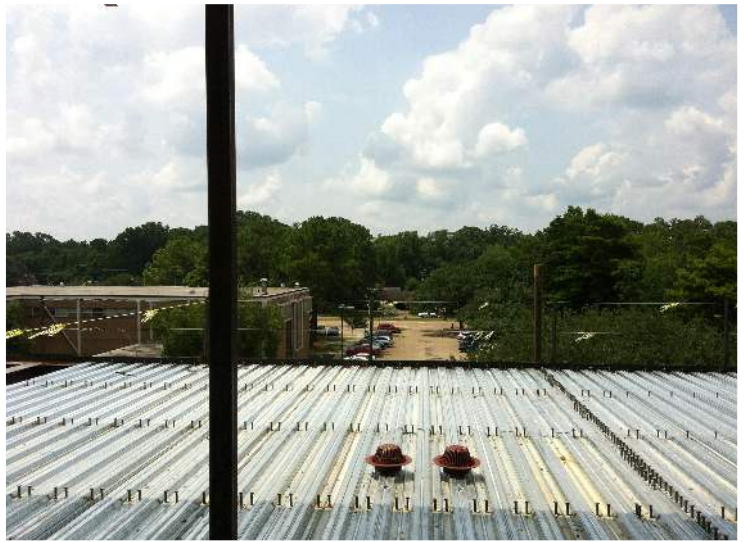
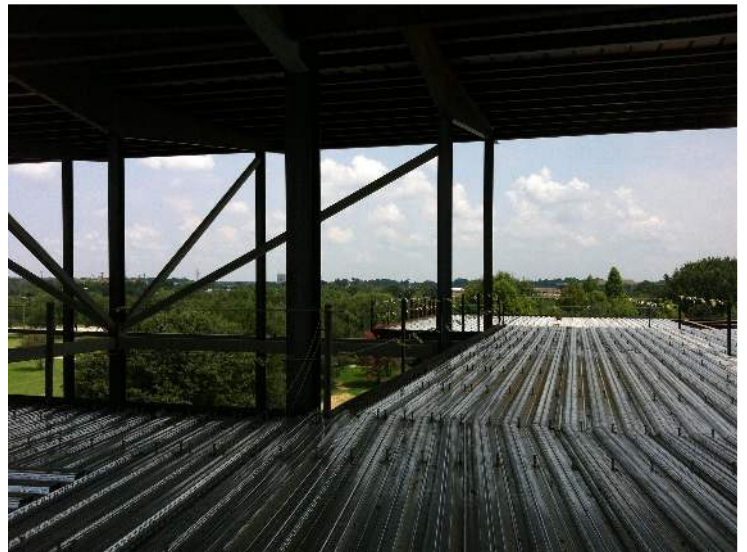
Refer to note 2b

- b. In reference to RFI no. 53, Design Change Request by the Contractor of the Parapet Electrical Outlets, the stub ups were placed outside of the parapet on the south roof although the change had not been approved. The architect conveyed to the contractor that these needed to be moved.
